DM-RAFC012-02

Dealer's Manual

Crankset (Inspection Method)

FC-R9100

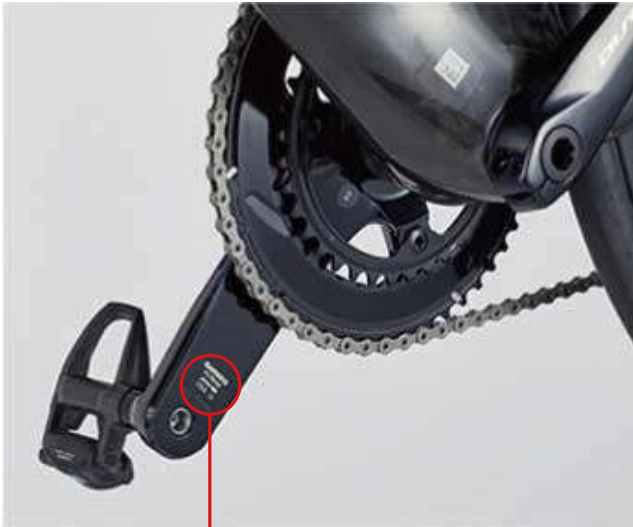
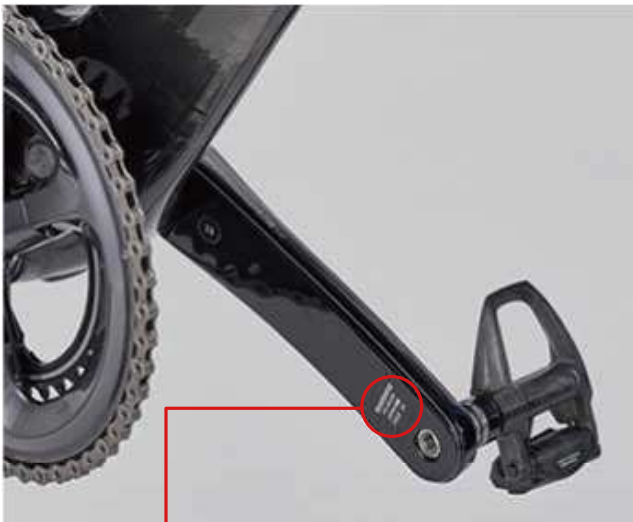
Before removing the crankset from the bicycle, confirm that the model number and production code match one of the target crankset models.

Model number

Production code

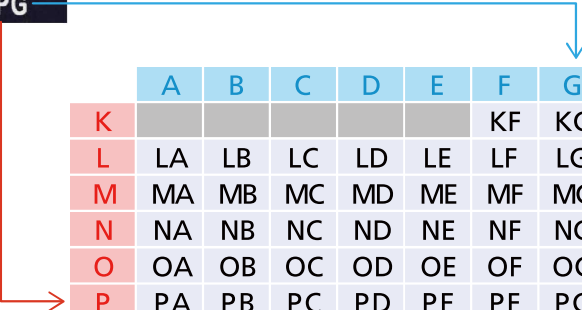
SHIMANO
FC-R9100
JAPAN VIA
172.5 PG

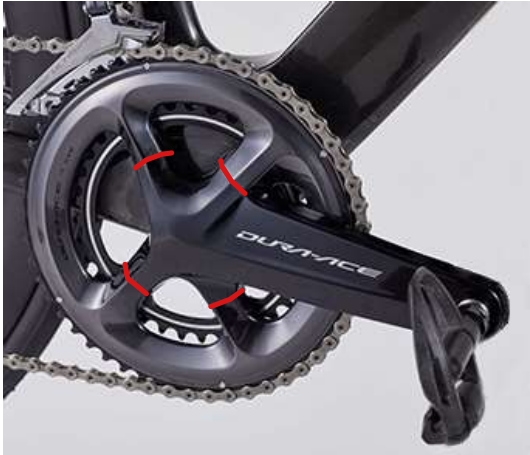
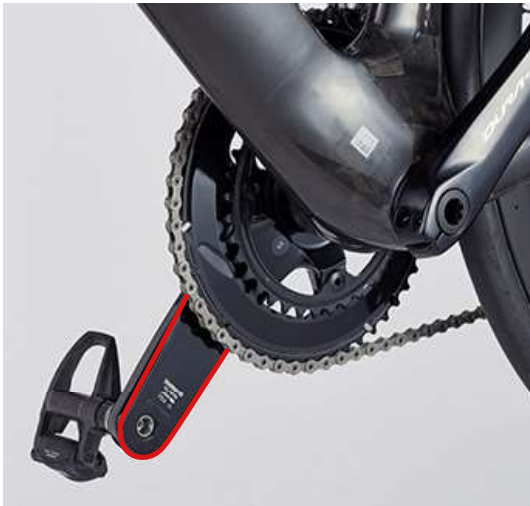
- **Right crank arm's bonded area**

Inspect for issues such as cracks or gaps, focusing on the areas indicated in red in the figures below.

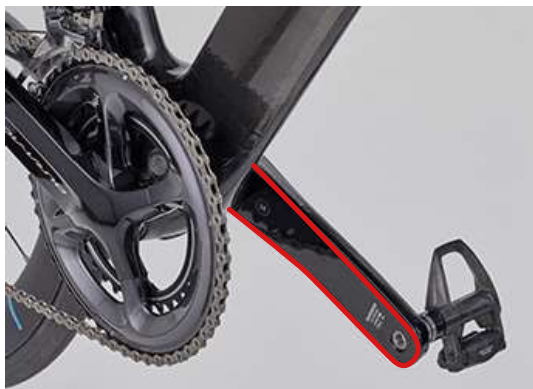
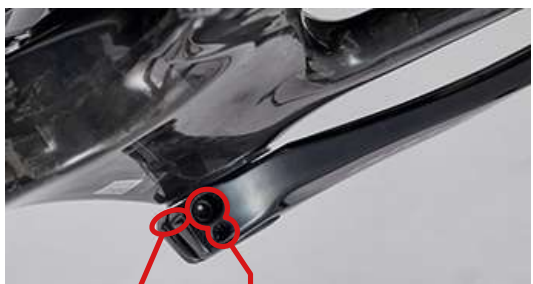
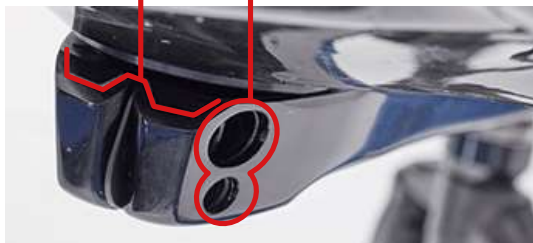
- **Left crank arm's bonded area**

Inspect for issues such as cracks or gaps, focusing on the areas indicated in red in the figures below.

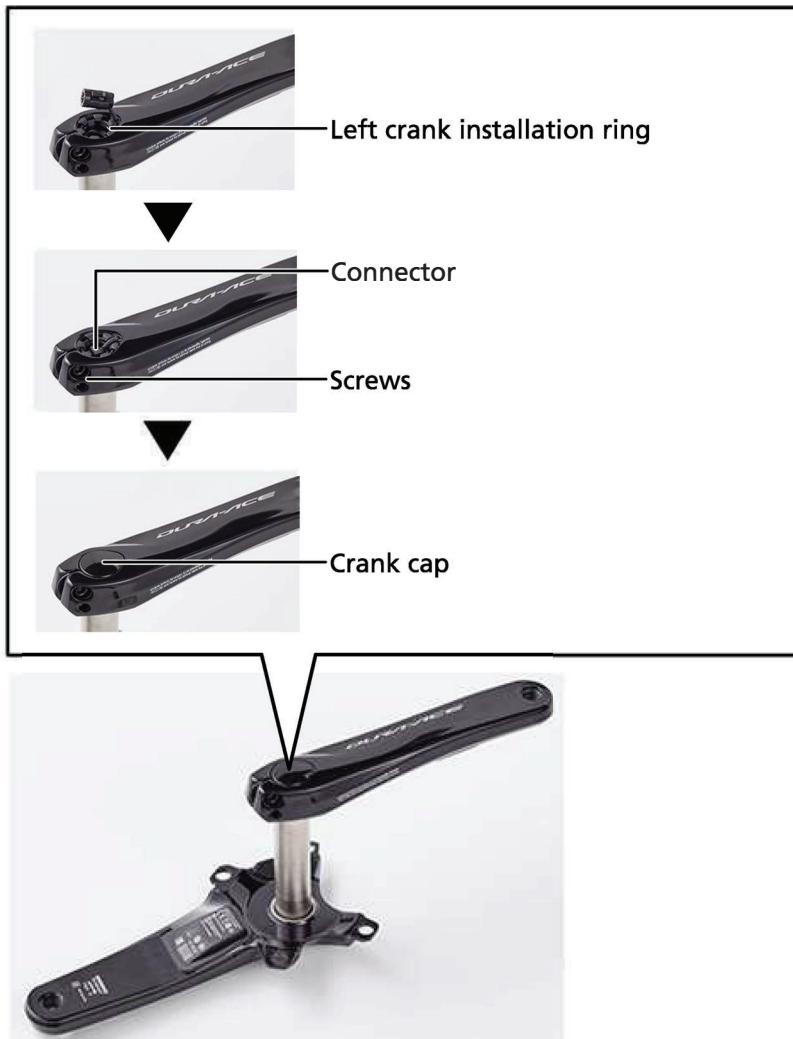
- After removing the left crank arm and right crank arm from the bicycle, install the left crank arm to the axle of the right crank arm.

Install the left crank installation ring, and insert the connector. Then, lightly tighten the two screws of the left crank arm so that they will not come off while cleaning, and correctly install the crank cap.

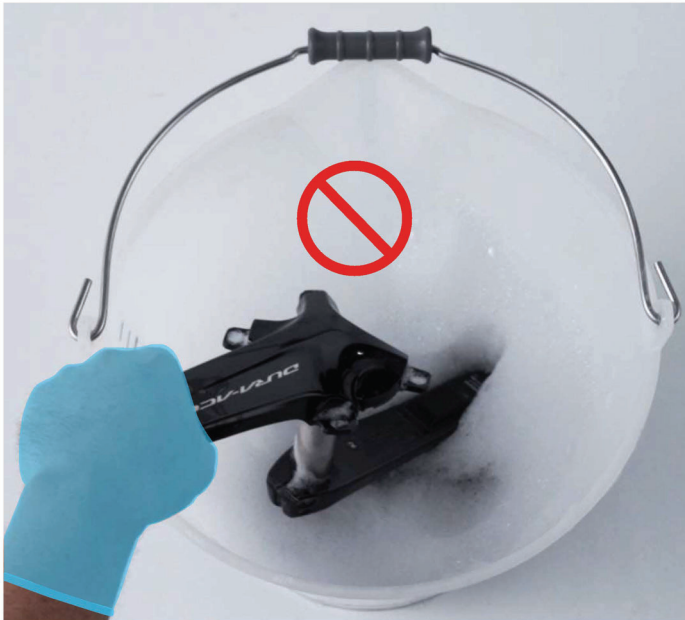
- Do not immerse the area around the connector in solvents.
Doing so may cause power meter failure.

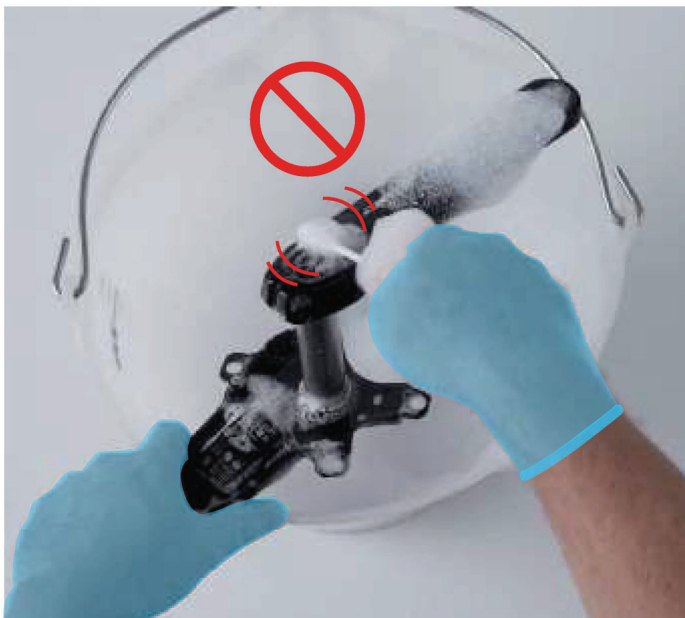
- Do not scrub the area around the connector too hard with a brush.

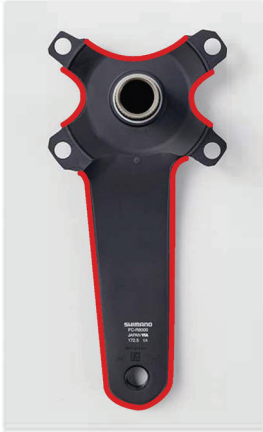
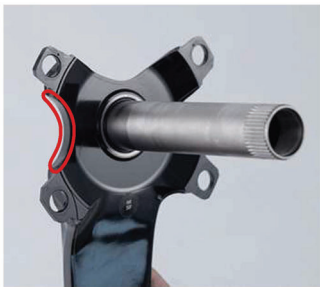
- Right crank arm locations of bonded area that must be cleaned thoroughly.

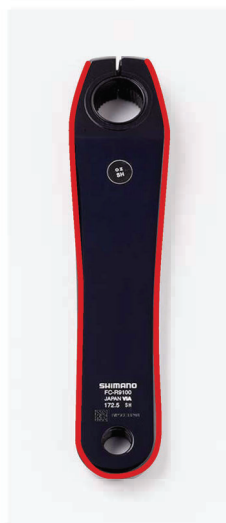
- Left crank arm locations of bonded area that must be cleaned thoroughly.

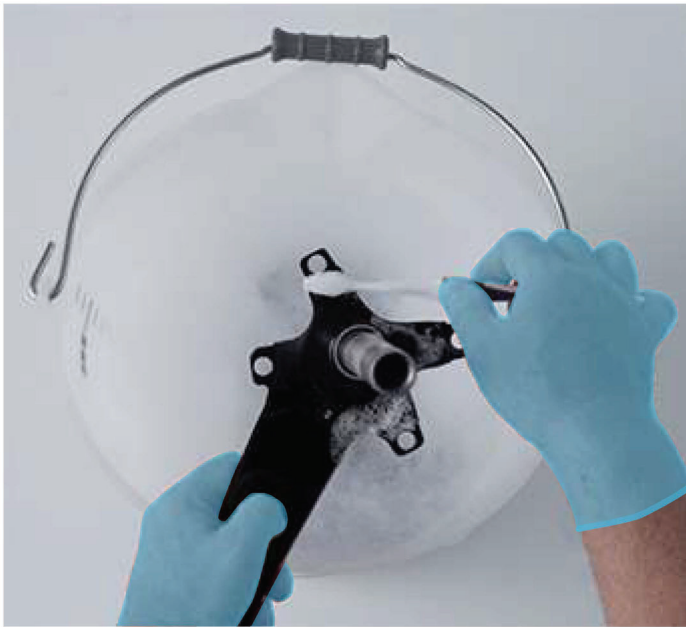
- Cleaning can be performed more thoroughly by using a small brush.

Before cleaning

After cleaning

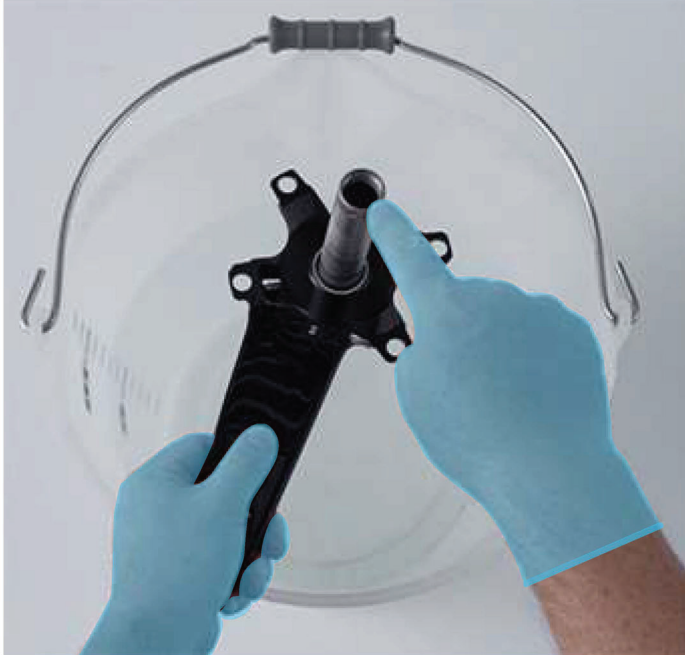
- Because detergent is prone to collect inside the axle, make sure to rinse the axle carefully with water, then dry it well.

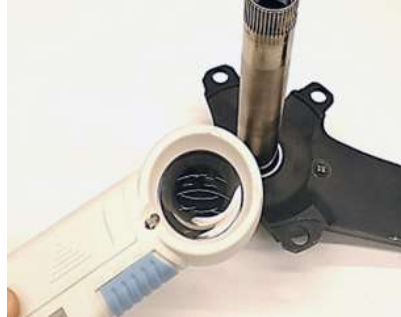
View through the magnifying glass, showing early signs of delamination

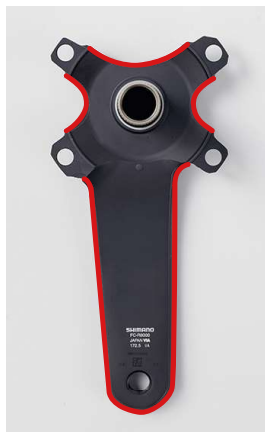
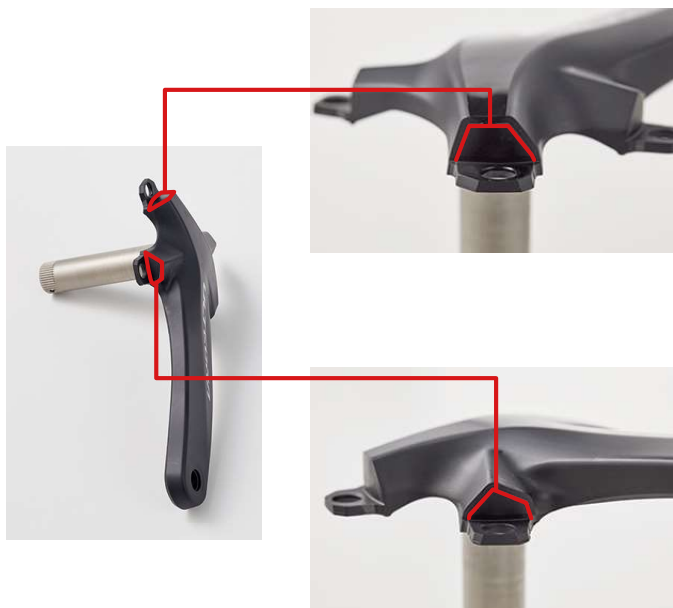
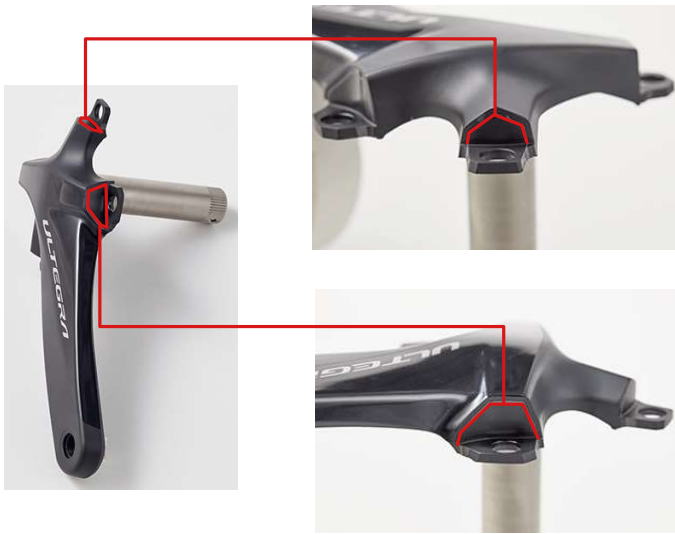
Right crank arm

Inspect for issues such as cracks or gaps, focusing on the areas indicated in red in the figures below.

Pay special attention to where the right-side crank is connected to the chainring, as this is the location where corrosion most frequently occurs, which can lead to delamination.

Chainring connection points

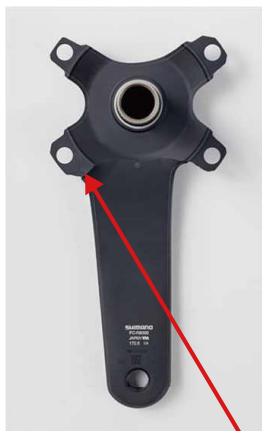
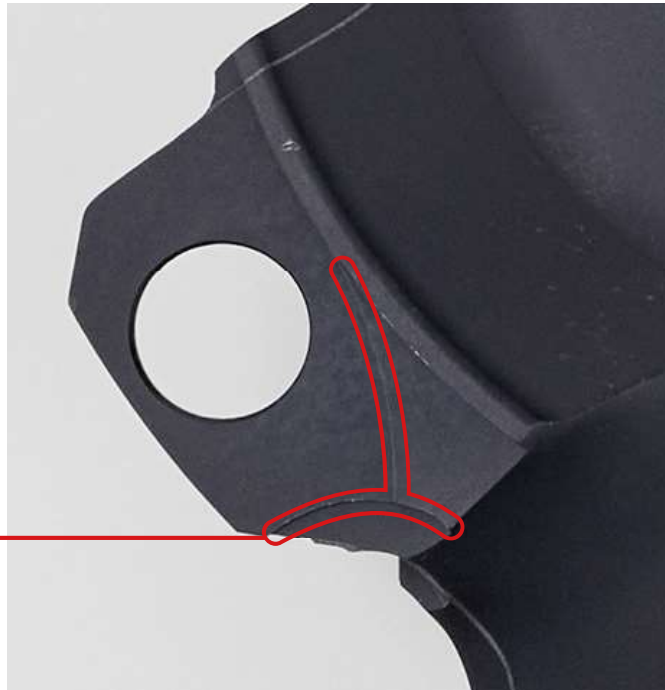
Areas that do not require inspection (FC-R9100 and FC-R8000)

- The gap outlined in red in the figure is the result of cutting during the manufacturing process, and does not require inspection.

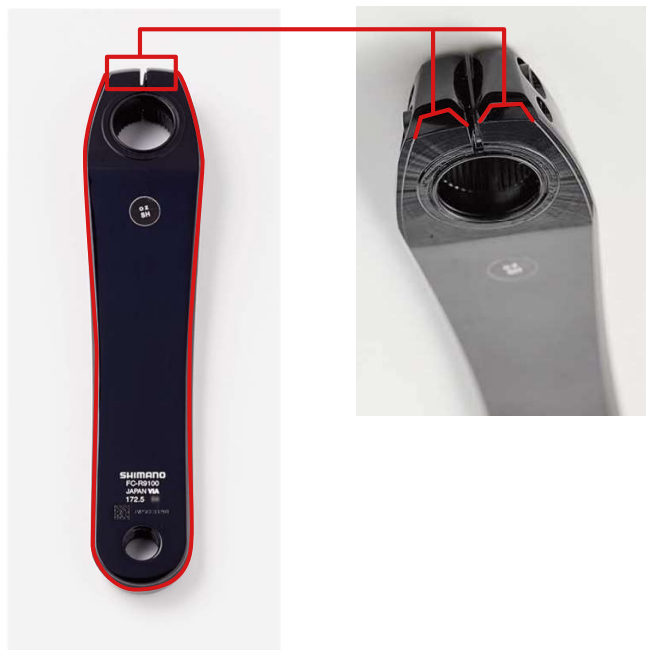
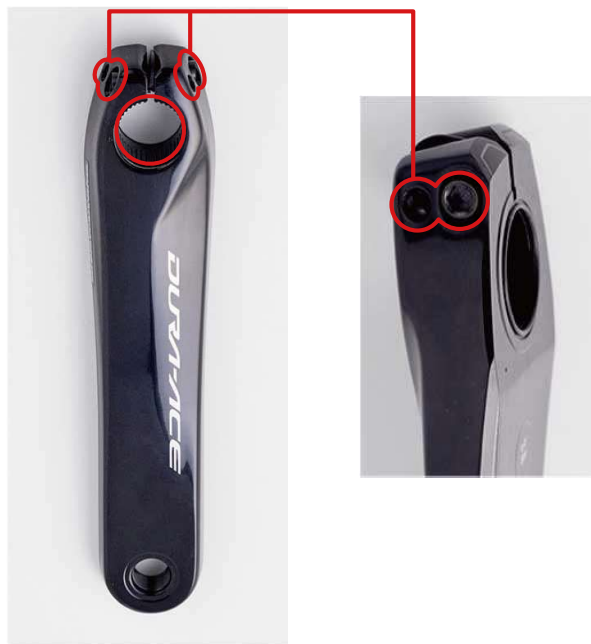
Left crank arm

Inspect for issues such as cracks or gaps, focusing on the areas indicated in red in the figures below.

Inspect the area around the screws on both sides of the left crank arm.

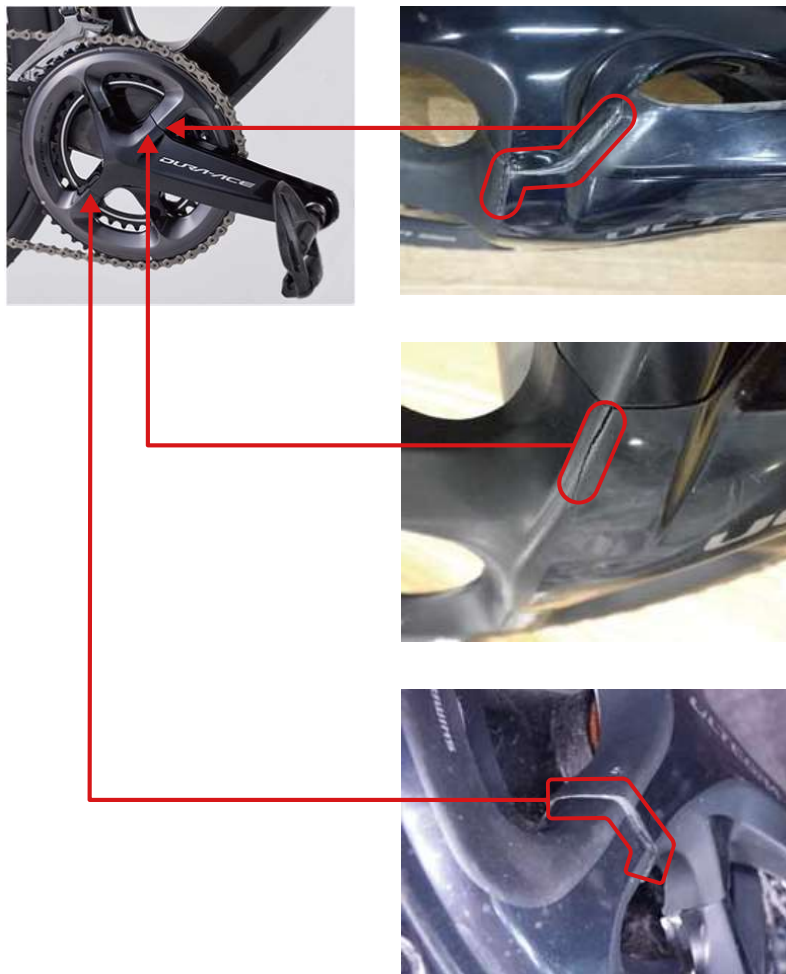
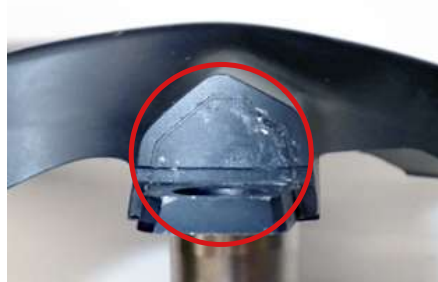
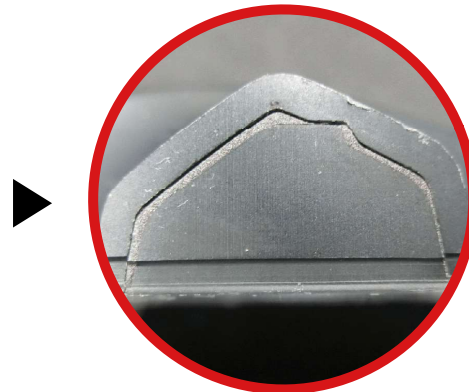
Sign of delamination and crack

View through the magnifying glass, showing early signs of delamination

Examine the joint area between the cover and the crank body carefully for any signs of delamination, since this might indicate that the crank arms are beginning to separate. Delamination can be seen in the form of cracks, steps and gaps.

There are cases where cracks or unevenness have been found around the gear attachment area, so please make sure to check carefully.

Shimano expects you to use a magnifying glass for inspections, which will make signs of delamination easier to identify. Shimano recommends use of an 11x power magnifying glass to enhance the inspections. If issues such as cracks or gaps are found in the crank arm, immediately stop use and replace the target product. If no issues are found even after inspection with the magnifying glass, refer to the [dealer's manual for the cranks](#) to reinstall the chainrings and the crankset.

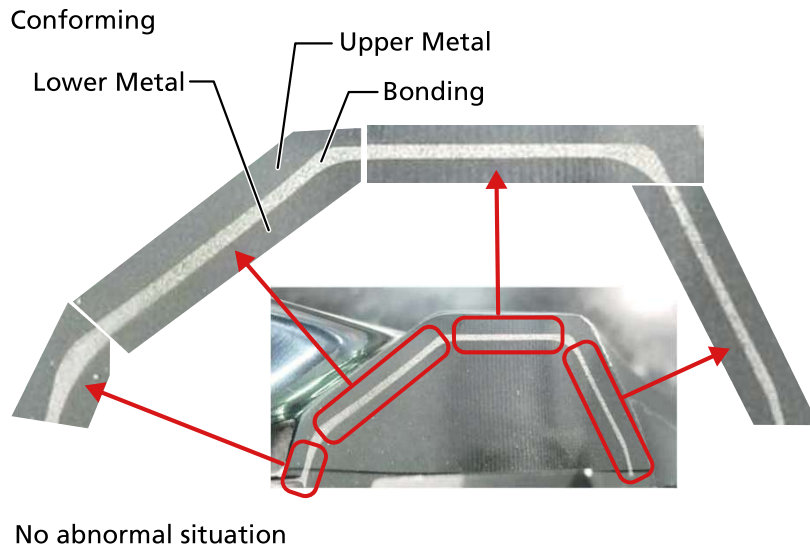
These are examples of cranks with no sign of delamination. There are no cracks between the bonding and the metal.

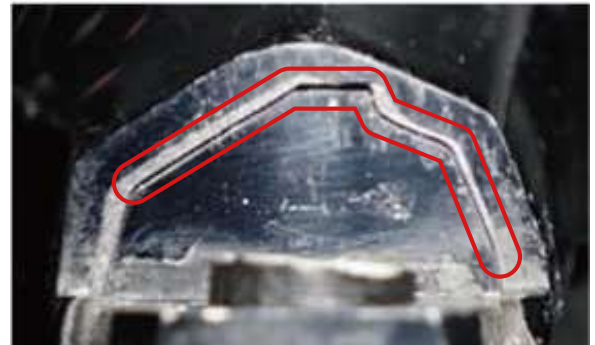
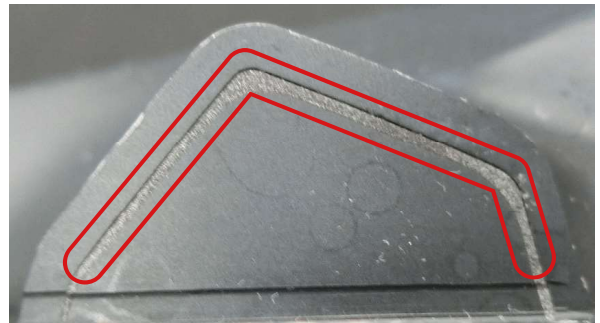
Non-conforming

These photos show examples of cracks that have formed between the bonding and the metal. This is an early sign of delamination.

Early sign of delamination with a tiny gap.

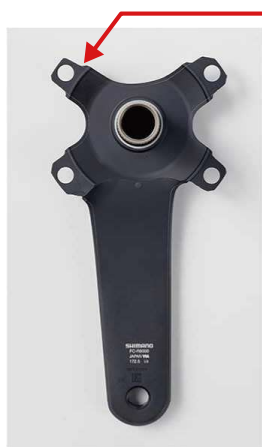
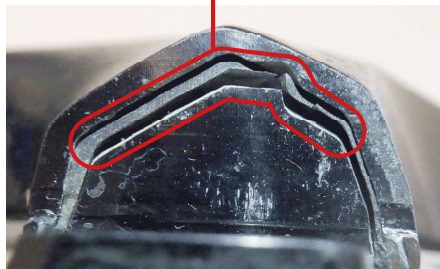
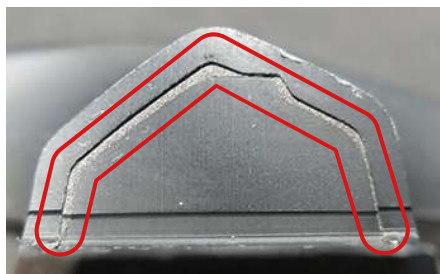
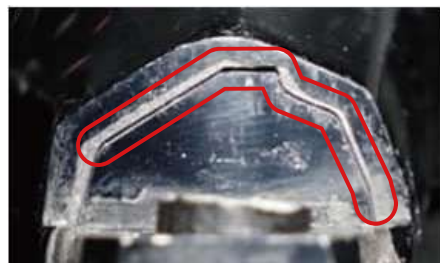
Non-conforming

These photos show additional examples of cracks that have formed between the bonding and the metal. This is an early sign of delamination.

There is a crack between the upper side metal and the bonding, and the lower side metal and the bonding.

There is a crack between the upper side metal and the bonding.

There is a crack between the lower side metal and the bonding.

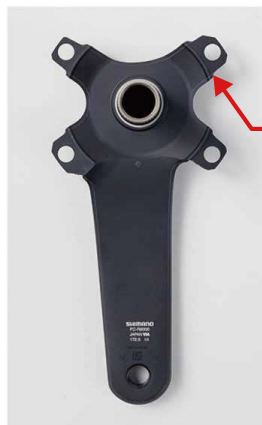
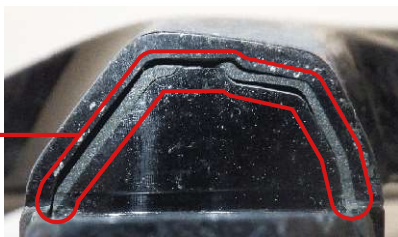
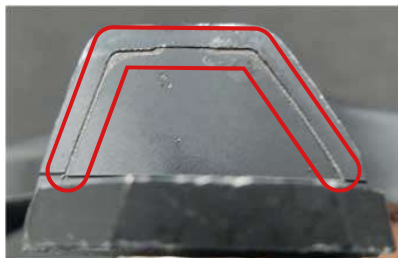
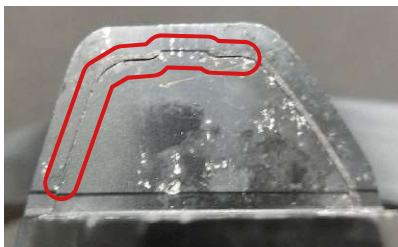
Non-conforming

There is a crack between the upper side metal and the bonding, and the lower side metal and the bonding.

There is a crack between the upper side metal and the bonding.

There is a crack between the lower side metal and the bonding.

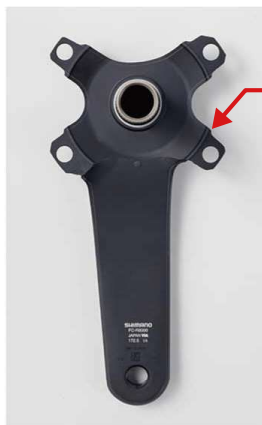
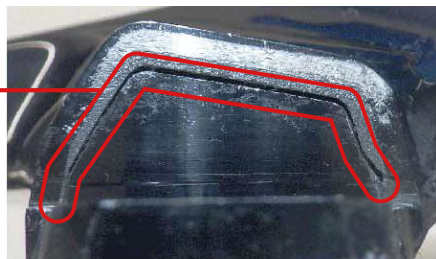
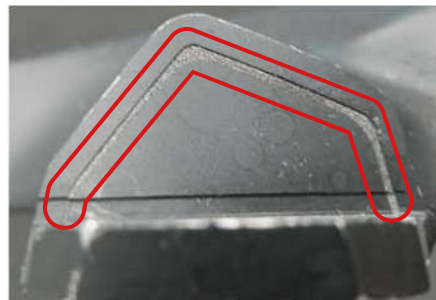
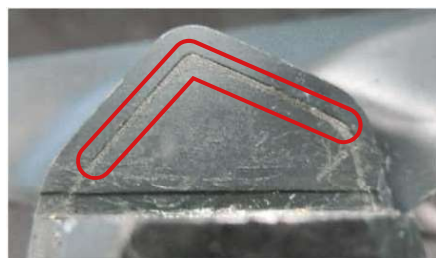
Non-conforming

There is a crack between the lower side metal and the bonding.

There is a crack between the upper side metal and the bonding.

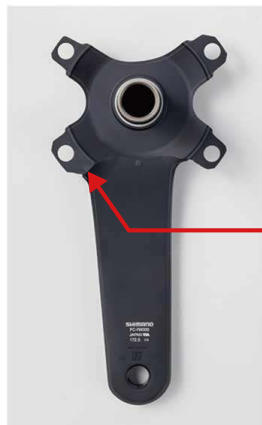
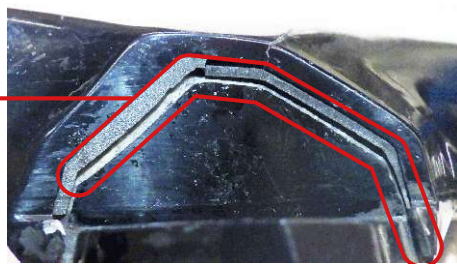
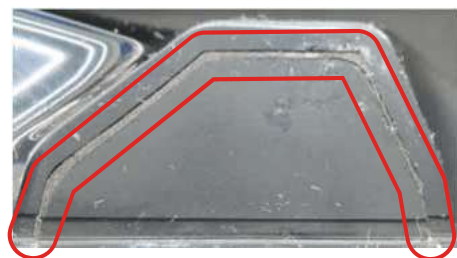
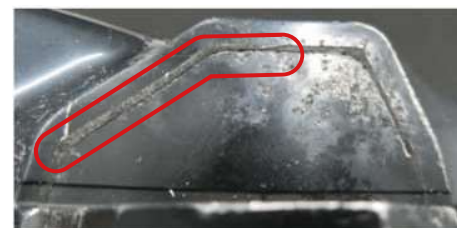
Non-conforming

There is a crack between the upper side metal and the bonding, and the lower side metal and the bonding.

There is a crack between the upper side metal and the bonding.

There is a crack between the lower side metal and the bonding.

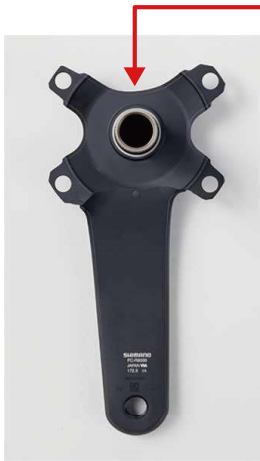
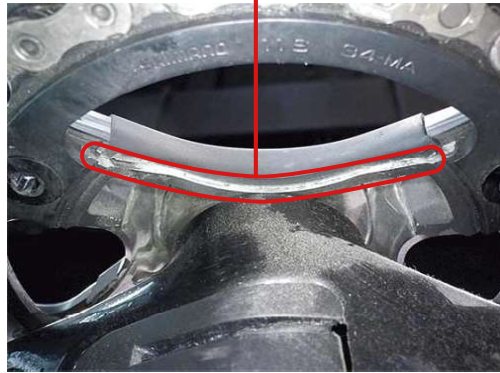
Non-conforming

There is a step between the upper side metal and the lower side metal, which means that the upper and lower metal surface joints are uneven and not smooth to the touch.

Delamination

There is a gap between the metal and the bonding.

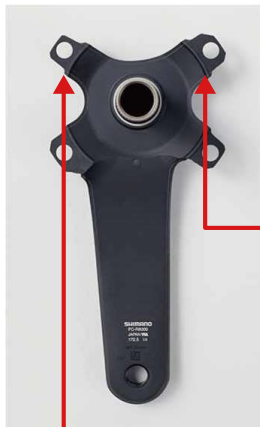
Sign of delamination through the magnifying glass

Non-conforming

Delamination with a small gap

There is a gap between the metal and the bonding.

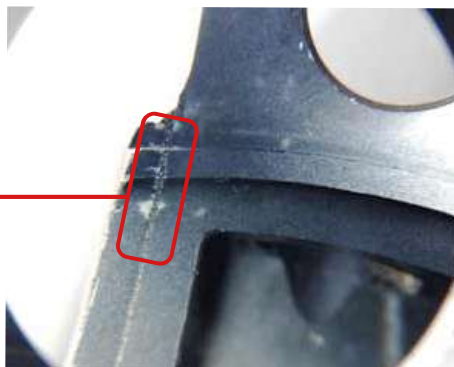
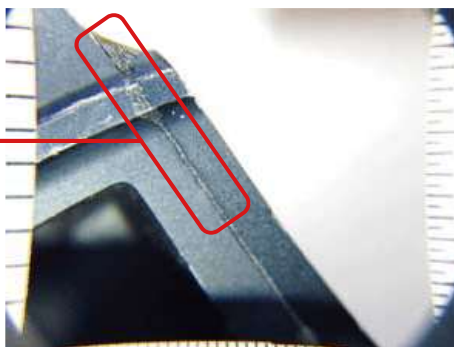
Two joint surface areas are uneven

There is a gap between the metal and the bonding.

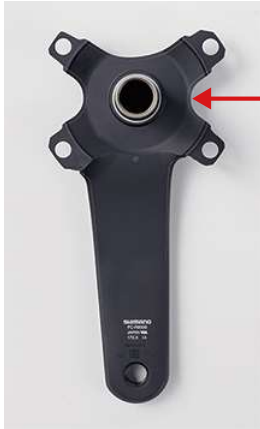
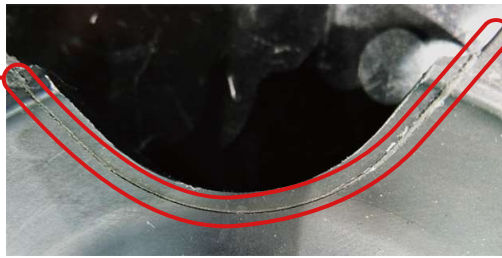
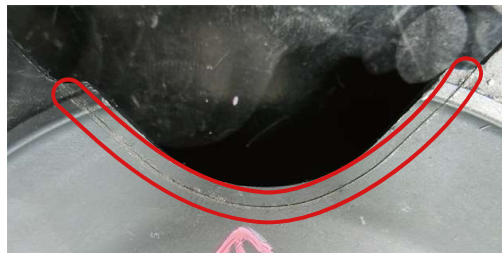
Non-conforming

There is a crack between the metal and the bonding.

There is a step between the upper side metal and the lower side metal, which means that the upper and lower metal surface joints are uneven and not smooth to the touch.

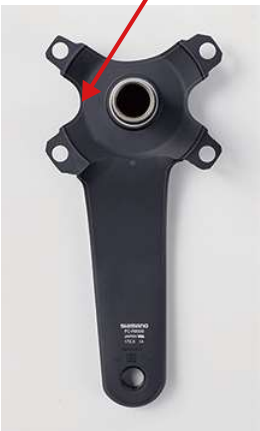
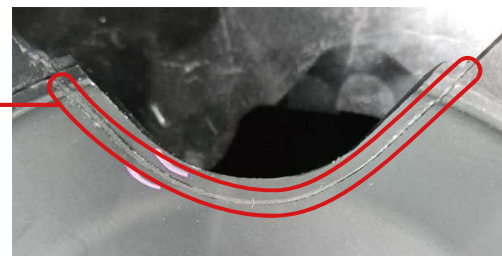
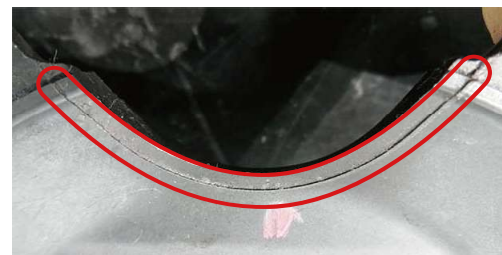
Non-conforming

There is a crack between the metal and the bonding.

Early sign of delamination with a tiny gap

There is a crack between the upper side metal and the bonding, and the lower side metal and the bonding.

Two uneven joint surfaces showing sign of delamination

There is a step between the upper side metal and the lower side metal, which means that the upper and lower metal surface joints are uneven and not smooth to the touch.

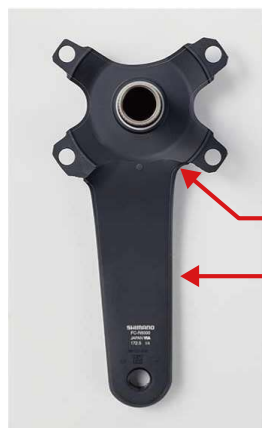
Sign of delamination through the magnifying glass

Non-conforming

There is a crack between the upper side metal and the bonding. And there is a lack of the bonding caused by delamination.

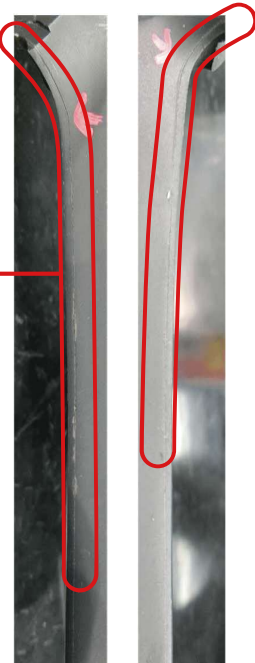
There is a crack between the metal and the bonding.

Early sign of delamination with a small crack

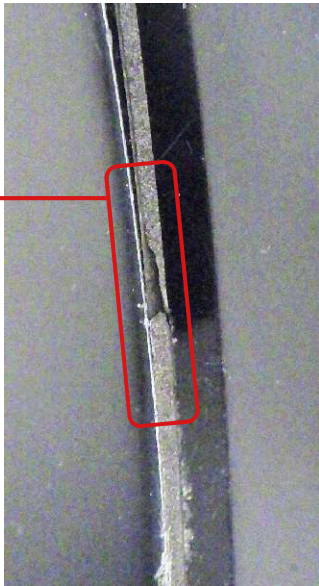
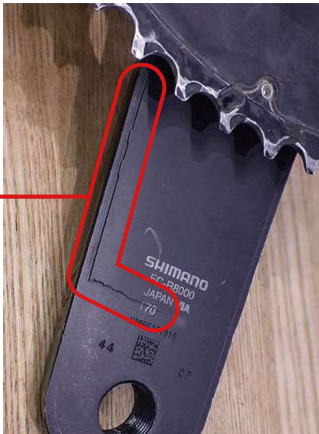
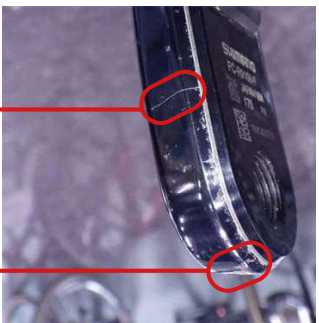
Non-conforming

There is a crack between the metal and the bonding. And there is a lack of the bonding.

There is a crack between the metal and the bonding. And there is a hairline crack caused by delamination.

Hairline crack caused by delamination

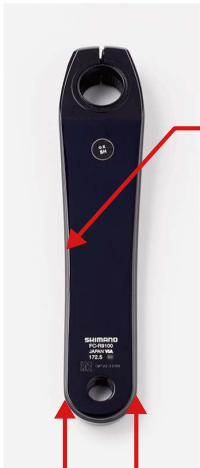
Non-conforming

There is a crack between the metal and the bonding.

Prominent lines developing between 2 joints

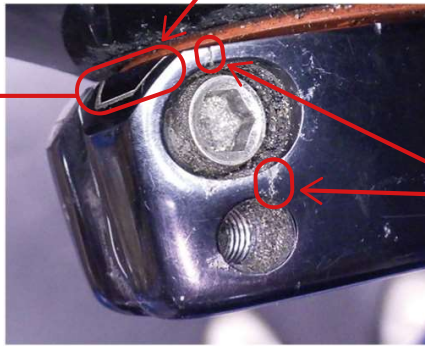
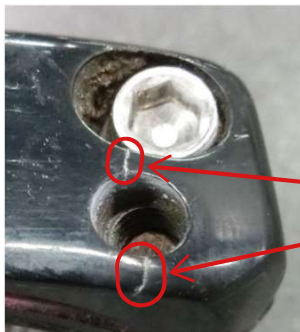
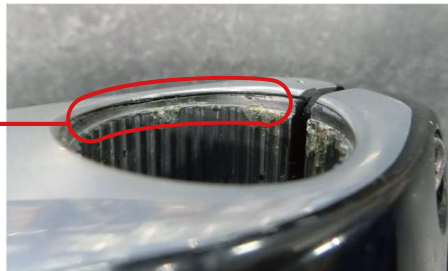
Non-conforming

There is a crack caused by delamination.

There is a crack between the metal and the bonding.

Small cracklines developing near clamp bolts

There is a crack between 2 metals.
